CITY OF PORT PHILLIP

# STREETSCAPE WSUD: Targeted Maintenance

Final Report

May 2014

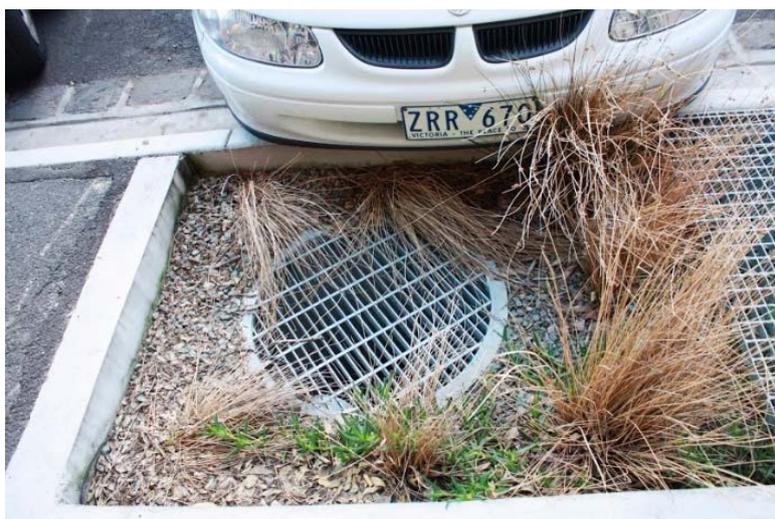
*LIKELY CAUSES:* Design issue, construction error (pit constructed low or filter media installed too high), sediment accumulation.

- Install a lip around the outlet pit to increase the ponding depth before the outlet structure is engaged
- Reduce the depth of the filter media (providing this will not result in <500mm filter depth)
- Remove sediment accumulation (see Section 5.11)

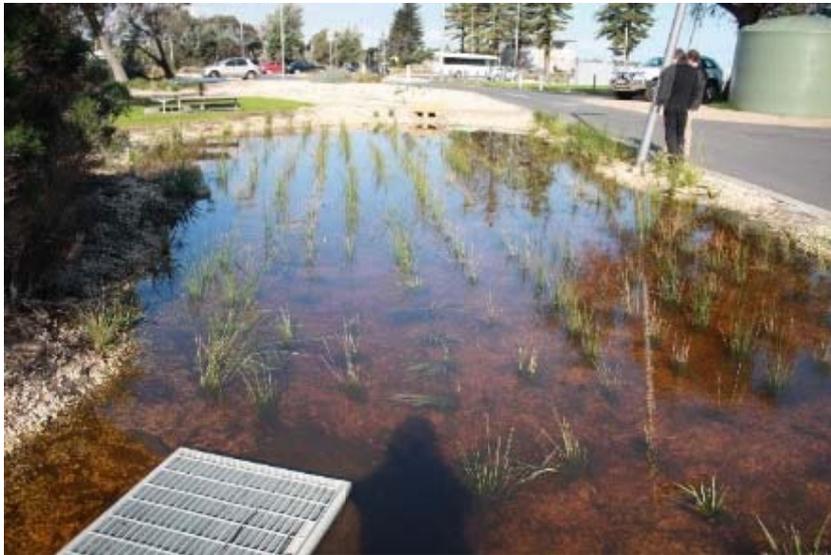
## 5.2 STANDING WATER ON SURFACE >12 HOURS AFTER RAINFALL

*ISSUE:* Standing water indicates impeded drainage through the filter media and therefore reduced water quality treatment capacity.

*LIKELY CAUSES:* High groundwater in the area around the raingarden or poor sub-soil infiltration rate (if unlined and designed to infiltrate), blockage of the filter media (clay layer, fine sediment etc), blockage in the underdrain.

- Investigation of surrounding groundwater conditions (seasonally high groundwater should be at least 0.5 m below the base of the drainage layer)
- Redesign of drainage pathways and outlet structures
- If media is clogged, scraping and replacement of top 100 mm of filter media or complete replacement of filter media material (See 5.11 further details)
- High pressure cleaning of underdrain

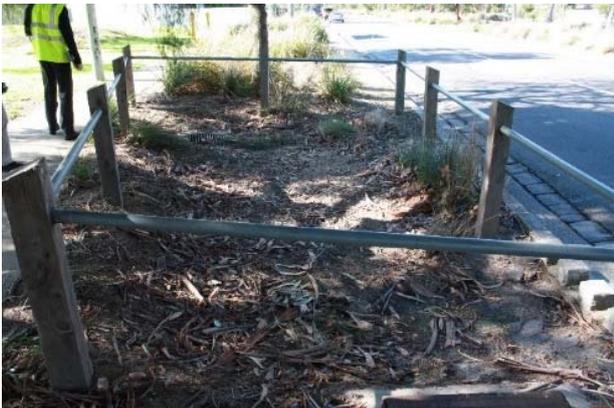
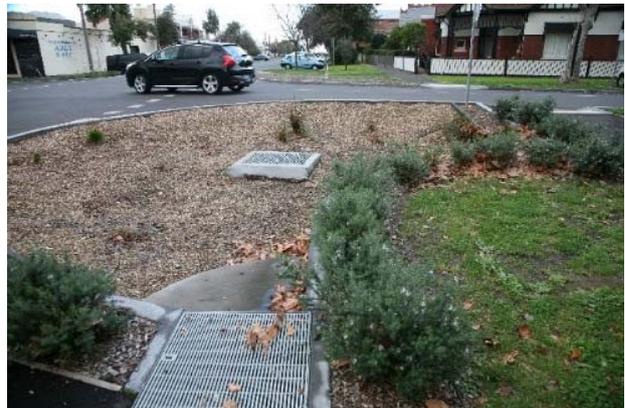
## 5.3 LARGE SCALE PLANT LOSS

*ISSUE:* Plants are a critical component of the functional performance of raingardens, especially in terms of stormwater treatment performance. They are also critical for long term raingarden aesthetics – an important factor for inner city and suburban streetscape raingardens. High plant densities significantly reduce the impacts (and therefore maintenance requirements) of leaf litter accumulation, weed growth and clogging as a result of clay or fine sediment build-up.

*LIKELY CAUSES:* Unsuitable species selection, inadequate planting, poor establishment phase maintenance, unsuitable filter media material (low water holding capacity), monoculture design, poor quality plant stock.

- Replanting and providing establishment phase program including monitoring, weeding, infill planting and irrigation if required
- Amendment of filter media to increase water holding capacity where soil moisture is identified as being deficient (the most common cause of large scale plant loss)
- Redesign of outlet structures to create a submerged zone, increasing water available to plants
- Review of plant species selection for given site conditions and hydrology
- Increase plant species diversity to provide a more robust design.

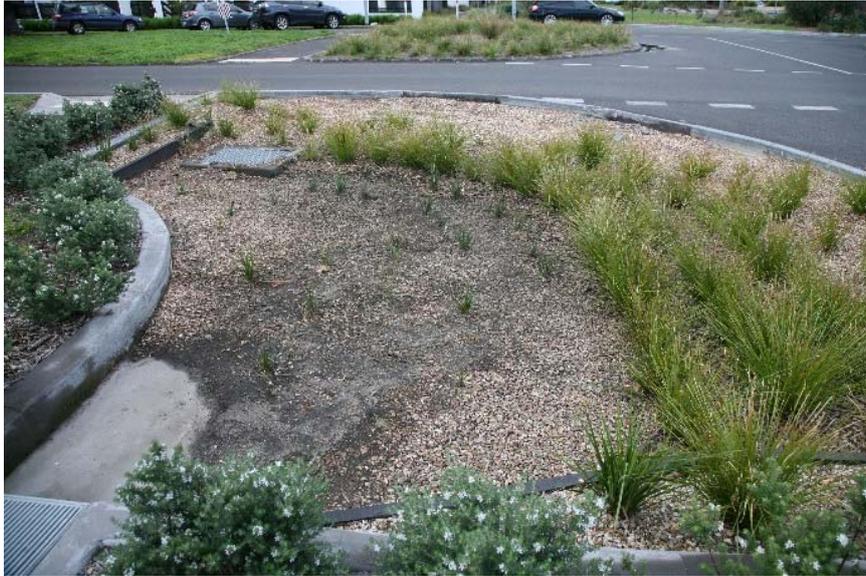
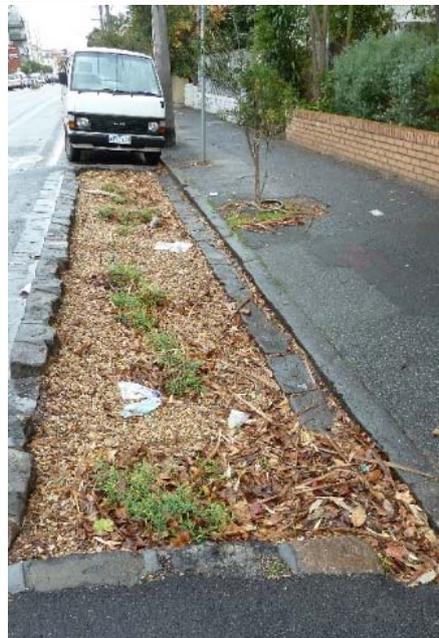
## 5.4 SIGNIFICANT LOSS OF A PARTICULAR SPECIES

*ISSUE:* High plant densities across the entire filter media surface are critical for maintaining infiltration capacity of the filter media, reducing impacts of erosion and weeds, providing water quality treatment.

*LIKELY CAUSES:* Inappropriate species selection, poor quality plant stock

- Review species selection and replant with plants species more suitable for the inundation conditions (i.e. wet conditions near the inlet, and dry conditions near the outlet and on the batter slopes)
- Review suitability of species for raingardens in Victoria

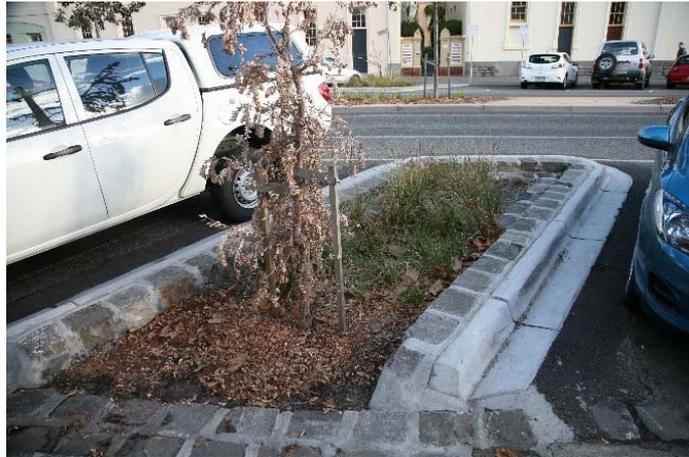
## 5.5 TREE LOSS

*ISSUE:* Trees loss reduces the aesthetics of raingardens as well as compromising water quality treatment performance.

*LIKELY CAUSES:* Inappropriate species for the hydrologic conditions

- Select a tree species more appropriate for the wetting and drying conditions within the raingarden
- Review the placement of the tree within the raingarden.

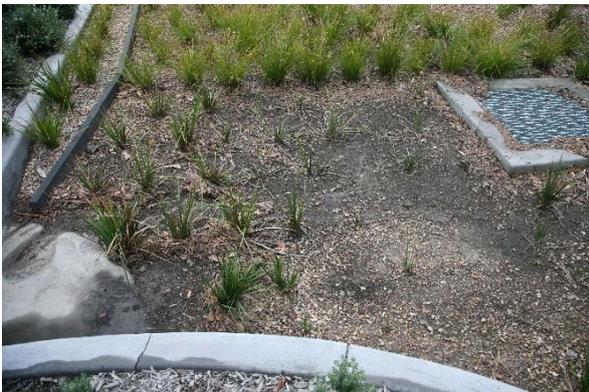
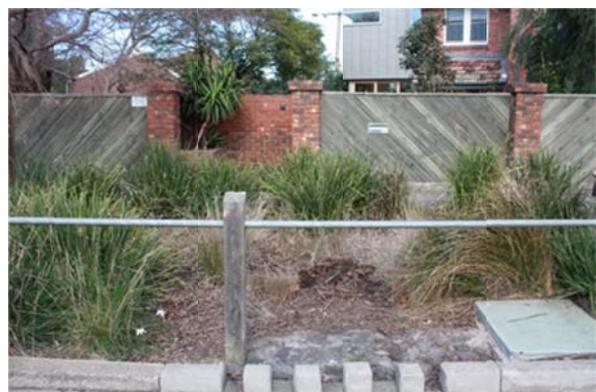
## 5.6 LOSS OF ALL PLANTS IN A PARTICULAR ZONE/AREA

*ISSUE:* High plant densities across the entire filter media surface are critical for maintaining infiltration capacity of the filter media, reducing impacts of erosion and weeds and providing water quality treatment.

*LIKELY CAUSES:* Inappropriate species selection, changed hydrologic conditions

- Review species selection and replant with plants species more suitable for the inundation conditions (e.g. wet tolerant species for wet conditions near the inlet, and drought tolerant species for dry conditions near the outlet and on batters)

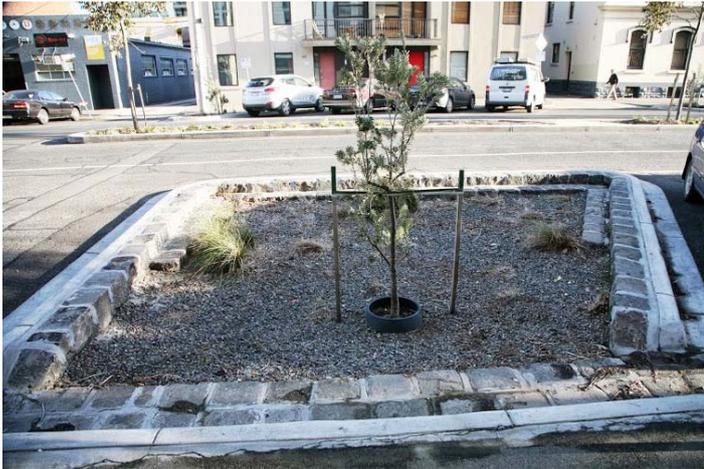
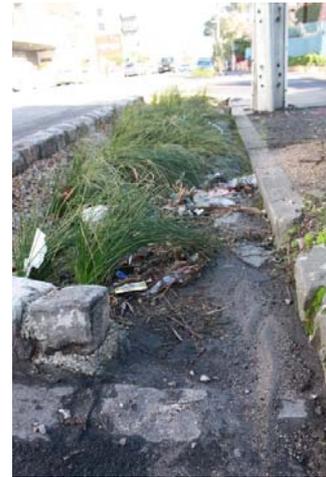
## 5.7 NO INFLOWS (INLET TOO HIGH, LOW FLOWS BYPASS RAINGARDEN)

*ISSUE:* Water quality treatment capacity is significantly affected if low flows are not directed onto the filter media surface.

*LIKELY CAUSES:* Design issue, construction error (levels)

- Reduce level of inlet if it presents a barrier to inflow
- Reduce the depth of the filter media (providing this will not result in <500mm filter depth)

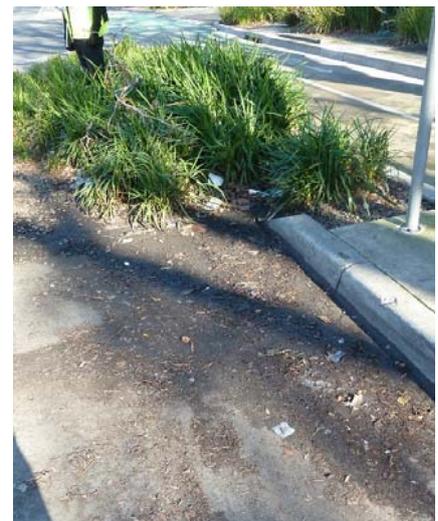
## 5.8 SIGNIFICANT SEDIMENT BUILD UP OR SCOUR AT INLET

*ISSUE:* Significant sediment or scour at the inlet can reduce inflows by causing bypass or prevent water from spreading evenly across the raingarden surface (both of which reduce water quality treatment capacity).

*LIKELY CAUSES:* Large catchment, severe storm event, poor velocity control at the inlet, lack of grade at inlet

- Remove plants as needed and set aside. Remove sediment and gravel mulch, repair any erosion or scour, ensure filter media surface level provides design ponding depth (100 – 300 mm typically). Undertake hydraulic conductivity testing to confirm infiltration rates. Replace plants at 6-12 plants/m<sup>2</sup>, providing infill planting if required.
- Consider installing sediment forebay (a small depression at the inlet to a raingarden comprising of large gravel or rocks, a depressed concrete area or grassed zone) to assist in velocity control and concentrating sediment deposition.
- Install rocks or concrete apron to dissipate flows through high velocity zone

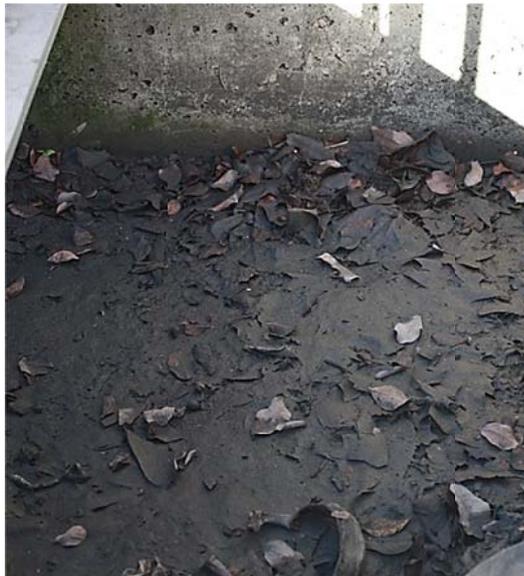
## 5.11 FINE SEDIMENT OR CLAY ON FILTER MEDIA SURFACE (SUBSTANTIAL VOLUME)

*ISSUE:* Significant sediment or clay on the filter media can result in clogging of the filter media, leading to bypass or prevent water from spreading evenly across the raingarden surface (both of which reduce water quality treatment capacity). Significant build up is likely to require corrective maintenance if it is deeper than 20mm or covers more than 60% of the surface area of the raingarden.

*LIKELY CAUSES:* Construction in catchment, unusual catchment characteristics, spill or other one-off episode, long term accumulation of sediment or fine material imported with the gravel mulch.

- Remove existing plants and store appropriately. Use hand tools or appropriate machinery to scrape off the top 100mm of filter media. Undertake in-situ hydraulic conductivity testing. If underlying filter media retains design infiltration rate (or similar, hydraulic conductivity tests typically have an accuracy of  $\pm 50\%$ ), replace top 100mm with appropriate filter media material. If drainage rate not adequate, determine whether complete reset is required (replacement of entire depth of filter media). Dispose of or reuse mulch elsewhere (e.g. in regular garden beds). Replant existing plants and provide infill planting to ensure at least 6-12 plants/m<sup>2</sup> (depending on species) coverage once established.
- Monitor sediment accumulation every three months after rectification to identify any ongoing high sediment loads.

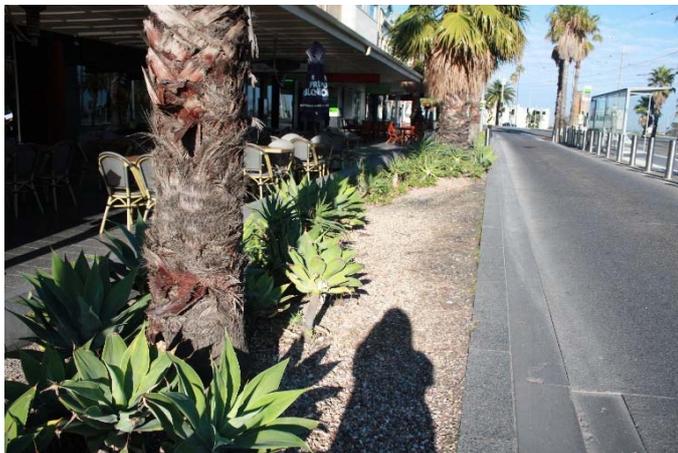
## 5.12 VISIBLE COMPACTION DUE TO PEDESTRIAN OR VEHICULAR TRAFFIC

*ISSUE:* When WSUD street scale assets are persistently impacted by traffic or pedestrian damage (e.g. compaction of the filter media and plant loss) those areas of the asset are no longer functional.

*LIKELY CAUSES:* raingarden located in natural vehicular or pedestrian route, tight street corners

- Vehicles:
  - Redesign such as reshaping kerbs and rounding off corners of street scale assets to provide more room for traffic.
  - Installation of bollards to restrict access
- Pedestrians:
  - Preventing access (i.e. dense tall planting, installing fences or other barriers)
  - Redirecting natural pedestrian routes (wider footpaths, revising or clearly marking parking locations, installing boardwalks etc)

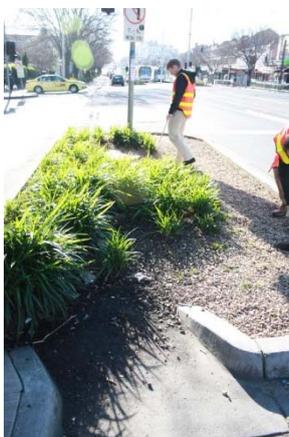
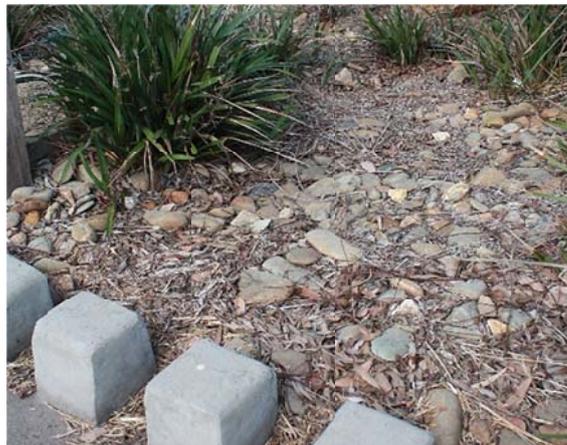
1. It can make sediment removal challenging. If fine sediment or clay washes in from the catchment, it accumulates between the gravel particles and then the task of sediment removal is more laborious because the gravel mulch must be removed and washed or replaced.
2. It restricts the growth and spread of the desired plant species (often due to heat trapped by the gravel).

*LIKELY CAUSES:* Designed for weed control

**Option 1 (preferred)** – Remove gravel with hand tools from around plants. Do not replace gravel mulch. Provide infill planting to ensure at least 6-12 plants/m<sup>2</sup> (depending on species) coverage once established.

**Option 3** – Maintain gravel mulch of between 5 and 10mm diameter, to a MAXIMUM of 25mm depth. Ensure desired planting densities are achieved and provide infill planting if necessary.
