CITY OF PORT PHILLIP

# STREETSCAPE WSUD: Targeted Maintenance

Final Report

May 2014

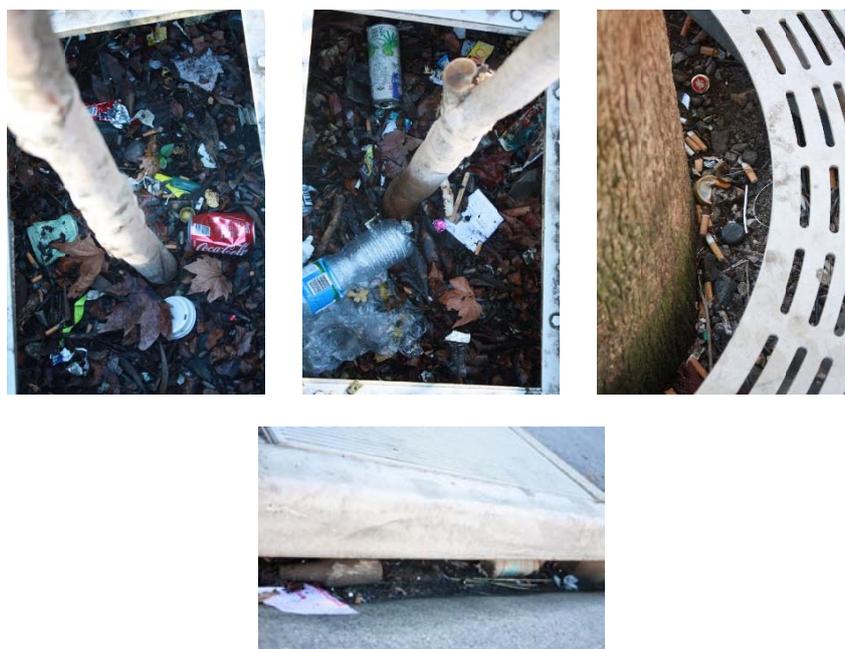
Leaf litter accumulation on a significant scale was observed at a number of sites within the City of Port Phillip. Where leaf litter posed a threat to WSUD asset function, it was primarily from Plane Trees (both overhead trees as well as from leaves washing in from the upstream catchment). Leaf litter can accumulate and become saturated within a WSUD asset. Breakdown of the leaves in saturated conditions can produce fine organic matter that can cause clogging of the filter media surface (eventually) and leach nutrients into waterways. A heavy leaf litter load can impede drainage through the filter media as well as restricting the growth and spread of desired plants in the WSUD asset.

Remove leaf litter from the surface of the filter media (including around inlet areas and between plants) using rakes or other appropriate hand tools. Remove leaf litter from hard surfaces using appropriate hand tools. Leaf litter must be removed from the site and composted or disposed of appropriately.

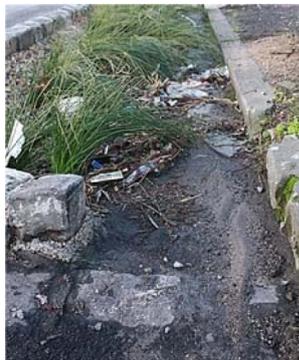
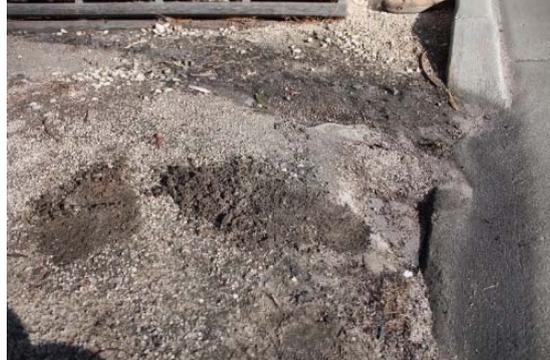
Most WSUD assets across the City of Port Phillip contain gravel mulch, however the size and depth of the gravel varies between sites. The presence of gravel mulch has two key drawbacks as identified at some sites across the City of Port Phillip:

1. It can make sediment removal challenging. If fine sediment or clay washes in from the catchment, it accumulates between the gravel particles and then the task of sediment removal is more laborious because the gravel mulch must be removed and washed or replaced.
2. It restricts the growth and spread of the desired plant species (often due to heat trapped by the gravel, pressure on the plant stems and potentially through abrasion or cutting of stems).

Option 1 (preferred) – Remove gravel with hand tools from around plants. Do not replace gravel mulch. Provide infill planting to ensure at least 6-12 plants/m<sup>2</sup> (depending on species) coverage once established. Inspection and removal of weeds should occur every three months for the first year following plant establishment.

Option 3 – Maintain gravel mulch of between 5 and 10mm diameter, to a MAXIMUM of 25mm depth.

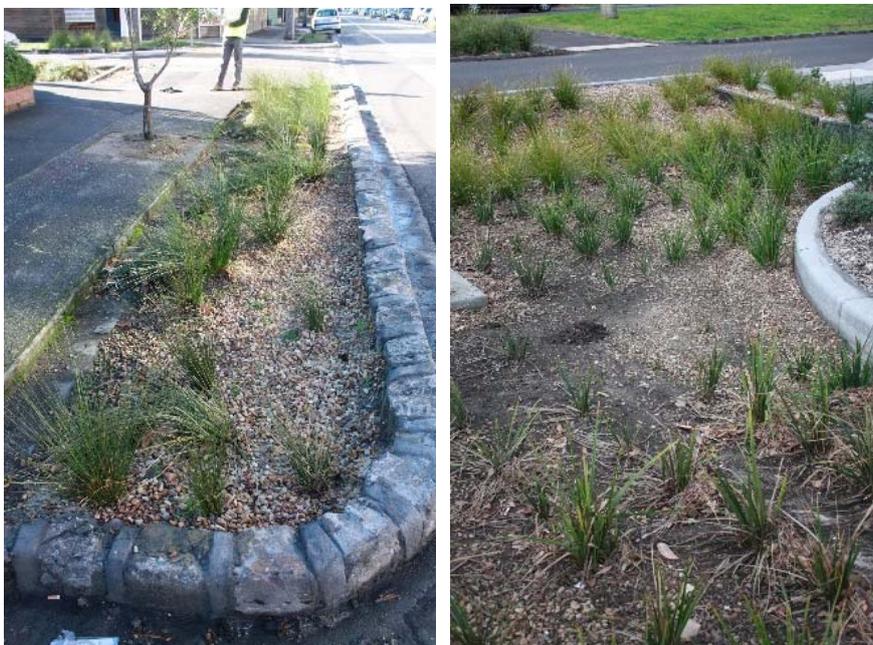
An inspection of street scale WSUD assets throughout the City of Port Phillip revealed few assets where weeds were a significant maintenance issue, although a few weeds were present in many of the assets. Weeds and nuisance plants species can impact the aesthetics and function of a raingarden and ideally, these plants should be removed as soon as they appear.

Option 2 – Herbicide application using spot spray, or similar targeted approach, only. Herbicide must be approved for use in proximity to waterways. This will minimise the potential impact on desirable species and reduce the likelihood of chemical residuals within the soil profile, or local waterways.

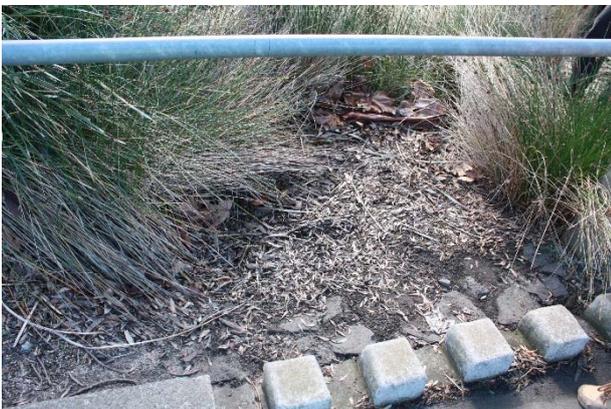
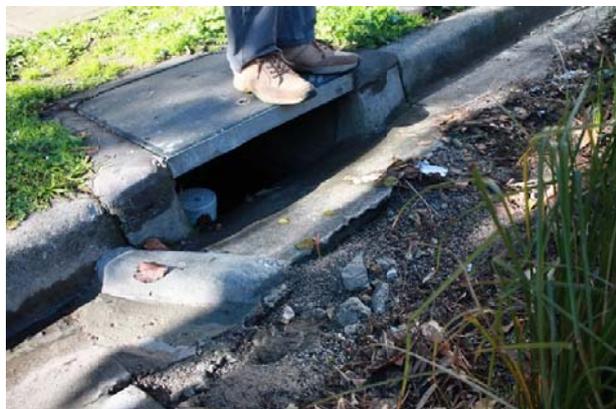
Erosion is typically caused by high velocity flows, poor vegetation cover, poor soil conditions or a combination. It is important to identify the cause of the erosion before undertaking maintenance works. The surface of a WSUD asset must have a profile that provides a flat surface area with no depressions, mounds or short circuit pathways between the inlet and outlet or overflow, as this can substantially reduce water quality treatment capacity.

**Minor erosion or scour** can be re-profiled with hand tools, limiting the damage to adjacent vegetation.

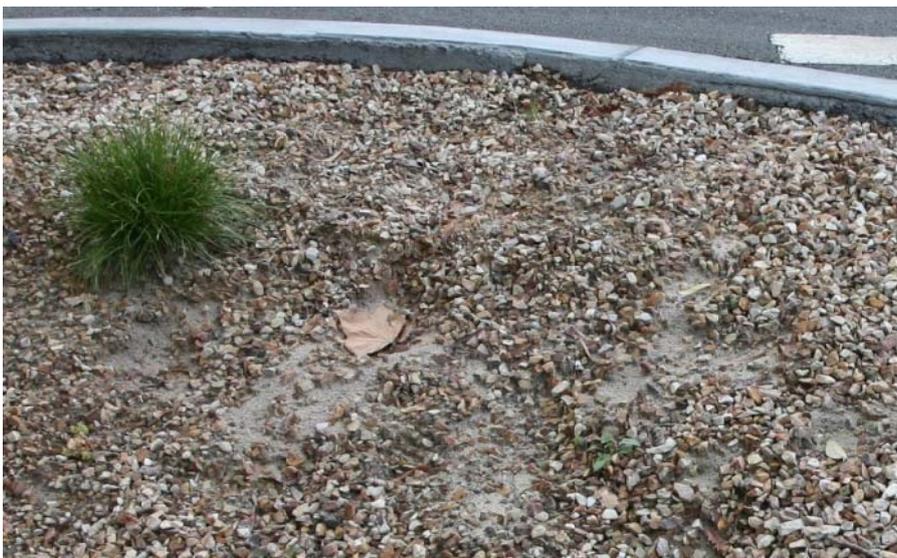
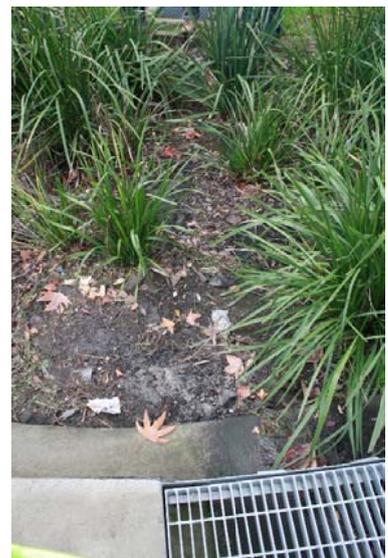
Clearing blockages from pits, pipes, inlets & outlets. Blockages of the civil infrastructure components of WSUD assets were more often observed at inlets, and in kerbs and gutters immediately upstream of WSUD assets. Generally consisting of sediment accumulation, leaf litter and rubbish (addressed in earlier sections of this report). However, any blockage that impedes flows into a raingarden, across the surface or down through the filter media must be removed. Blockages result in low flows bypassing the system, substantially reducing the water quality treatment performance and may also result in nuisance flooding during larger event flows. In severe cases, blockage can prevent water reaching plants resulting in plant loss.

Blockages should be removed manually, by hand or with hand tools such as tongs and shovels. Large blockages in pits may require vacuuming or other appropriate machinery.

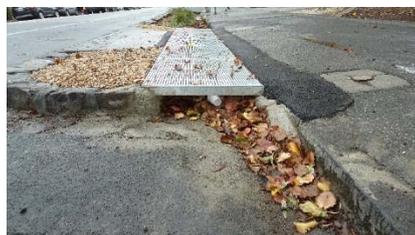
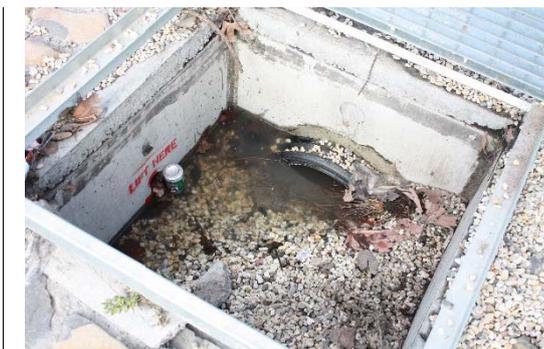
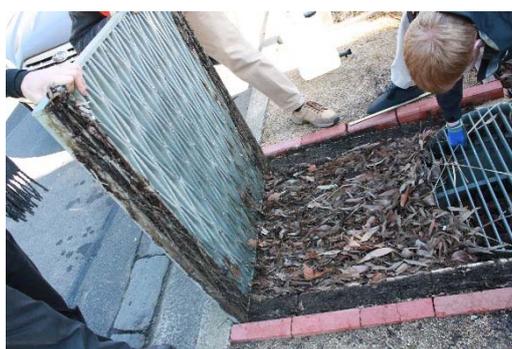
Vehicle damage was observed in a number of street scale raingardens within the City of Port Phillip. Typically, vehicle damage was observed where assets were located on tight street corners or in locations where vehicles were frequently pulling aside (e.g. taxis). If vehicle damage is an ongoing issue, then corrective maintenance is required (Section 5.12).

Ensure vehicle access is not an ongoing issue that requires traffic management (bollards etc). Loosen/till top 100mm of soil. Replant at densities  $>6$  plants/m<sup>2</sup> and protect during establishment phase.

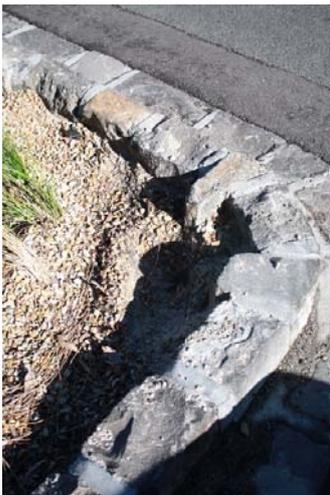
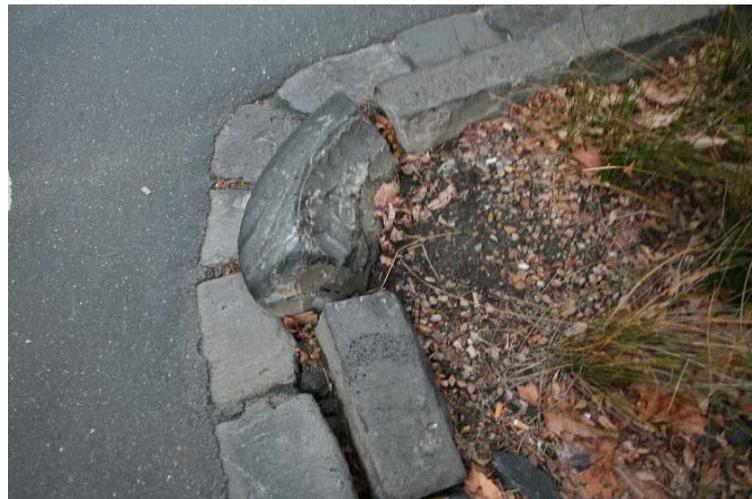
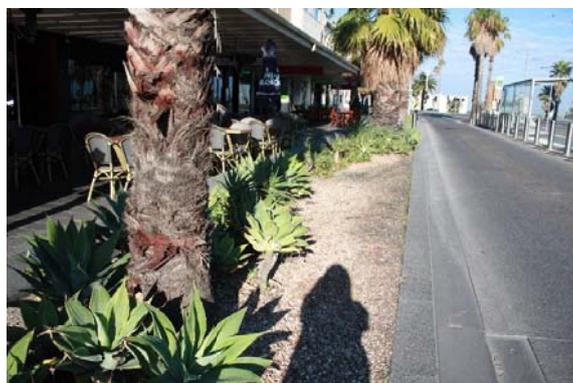
Pedestrian damage was observed in a few street scale raingardens within the City of Port Phillip. Pedestrian damage is typically due to foot traffic through the raingarden, causing compaction and plant loss. If pedestrian damage is an ongoing issue, then corrective maintenance is required (see Section 5.12).

Ensure pedestrian access is not an ongoing issue that requires corrective maintenance (preventing access through fences or redirecting natural pedestrian routes). Loosen/till top 100mm of soil. Replant with plants likely to deter access (tall, robust with dense foliage) at densities  $>6$  plants/m<sup>2</sup> and protect during establishment phase.

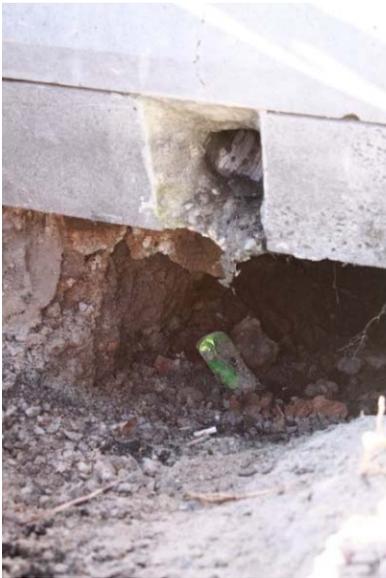
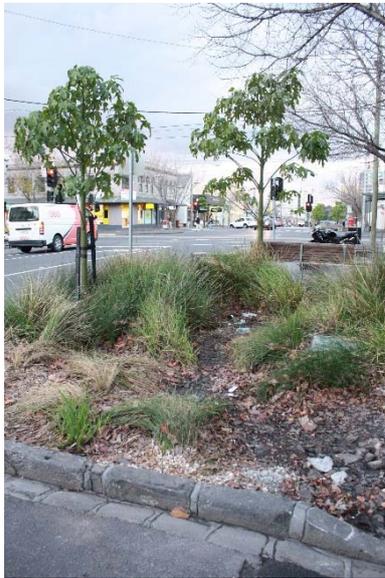
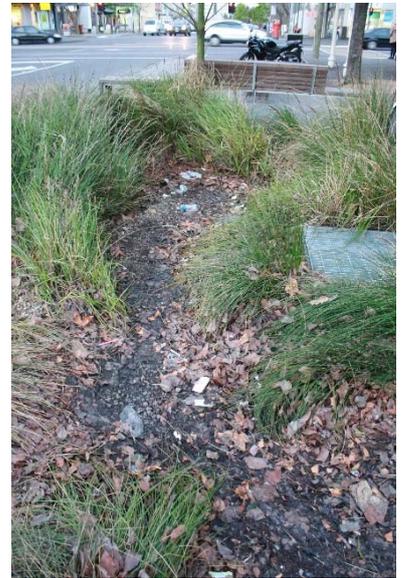
*ISSUE:* Significant sediment or clay on the filter media can result in clogging of the filter media, leading to bypass or prevent water from spreading evenly across the raingarden surface (both of which reduce water quality treatment capacity). Significant build up is likely to require corrective maintenance if it is deeper than 20mm or covers more than 60% of the surface area of the raingarden.
